**ASHLAND DAM**

**PHASE I INSPECTION REPORT  
NATIONAL DAM INSPECTION PROGRAM**

ASHLAND DAM  
SCHUYLKILL COUNTY, PENNSYLVANIA  
NATIONAL I.D. NO. PA 00659-  
671

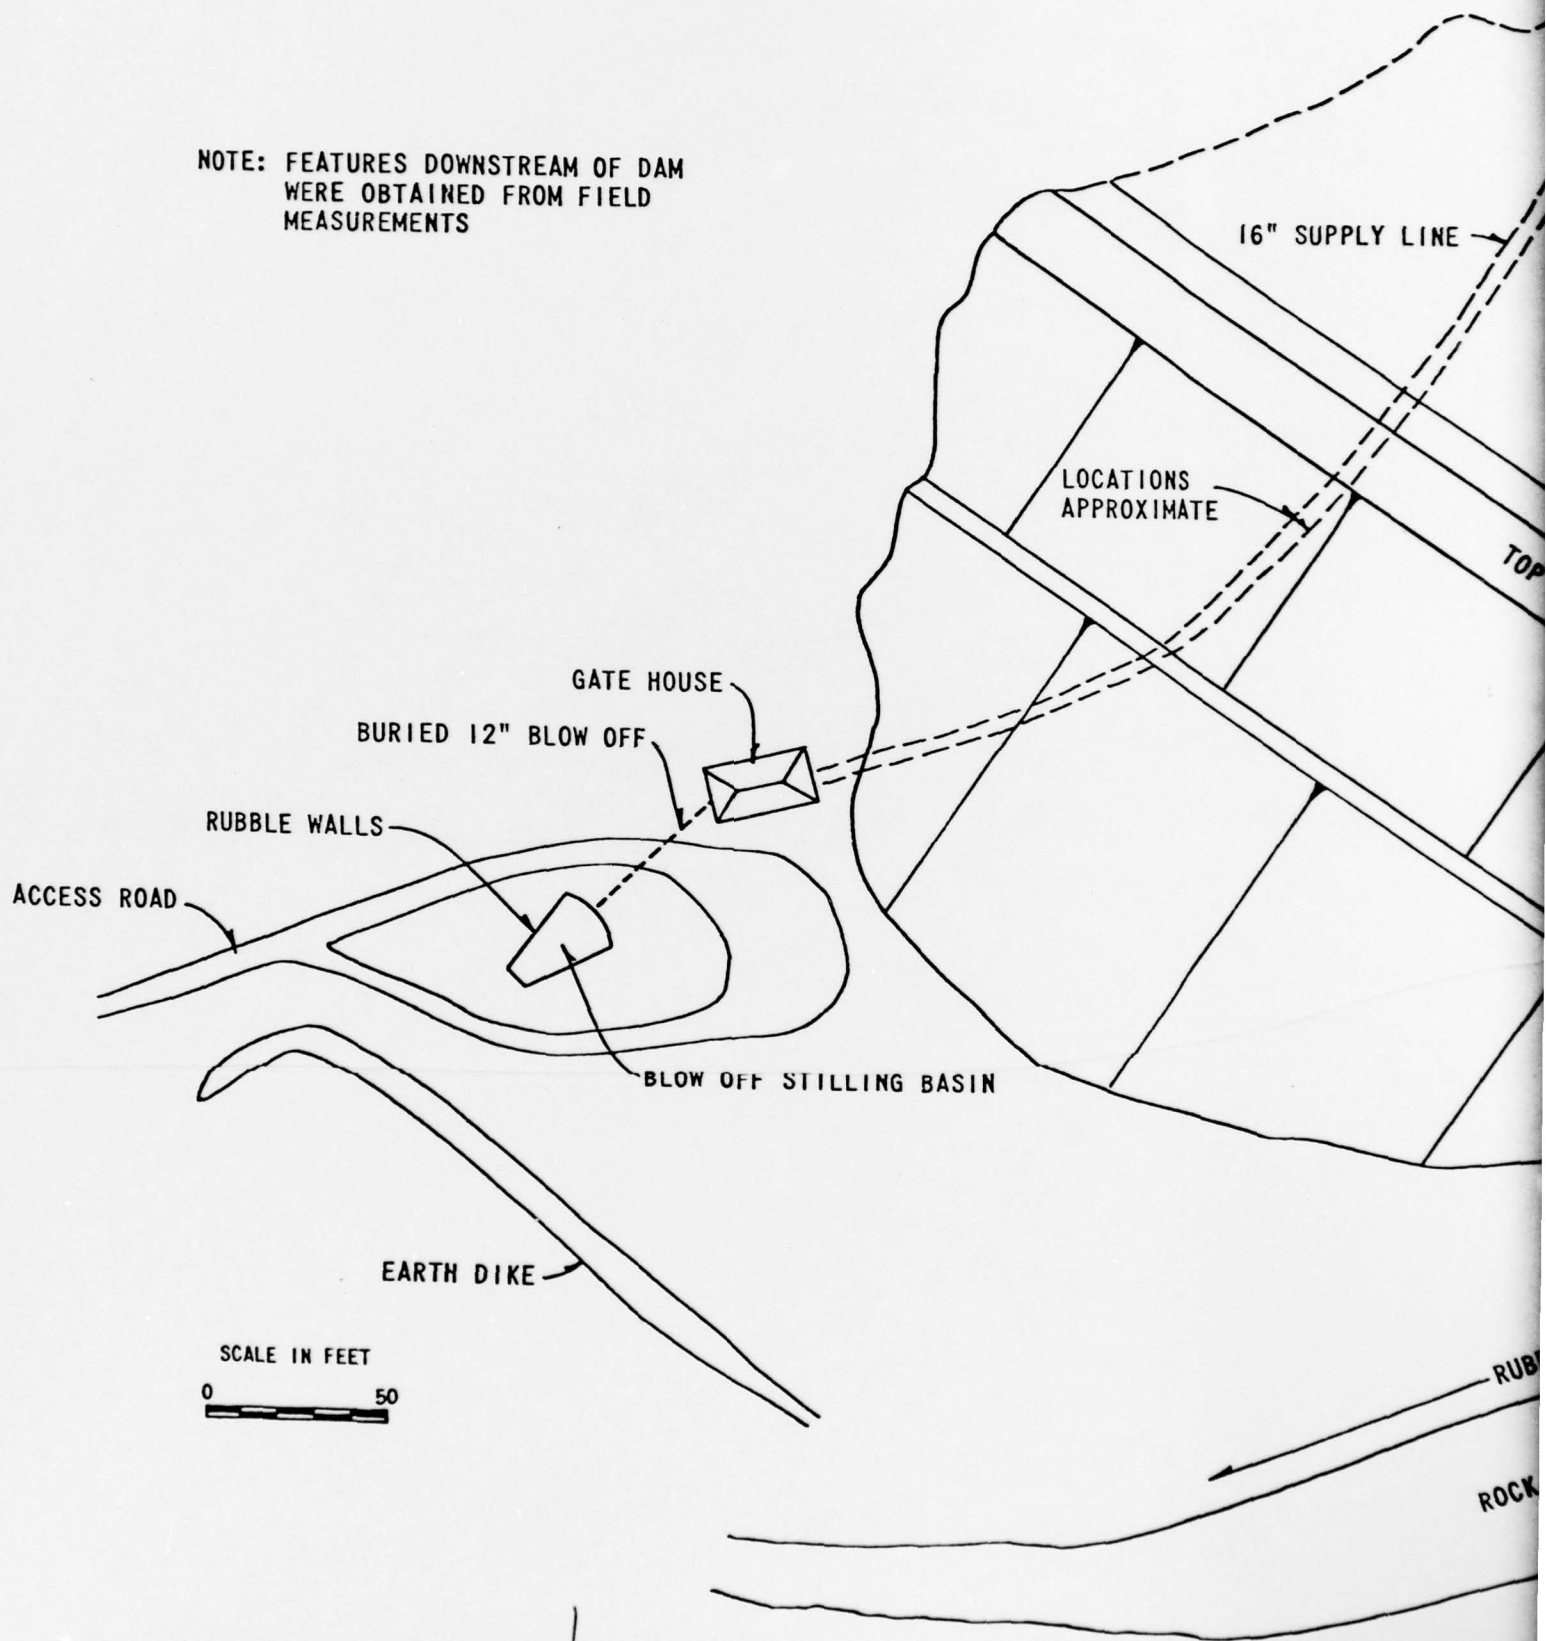
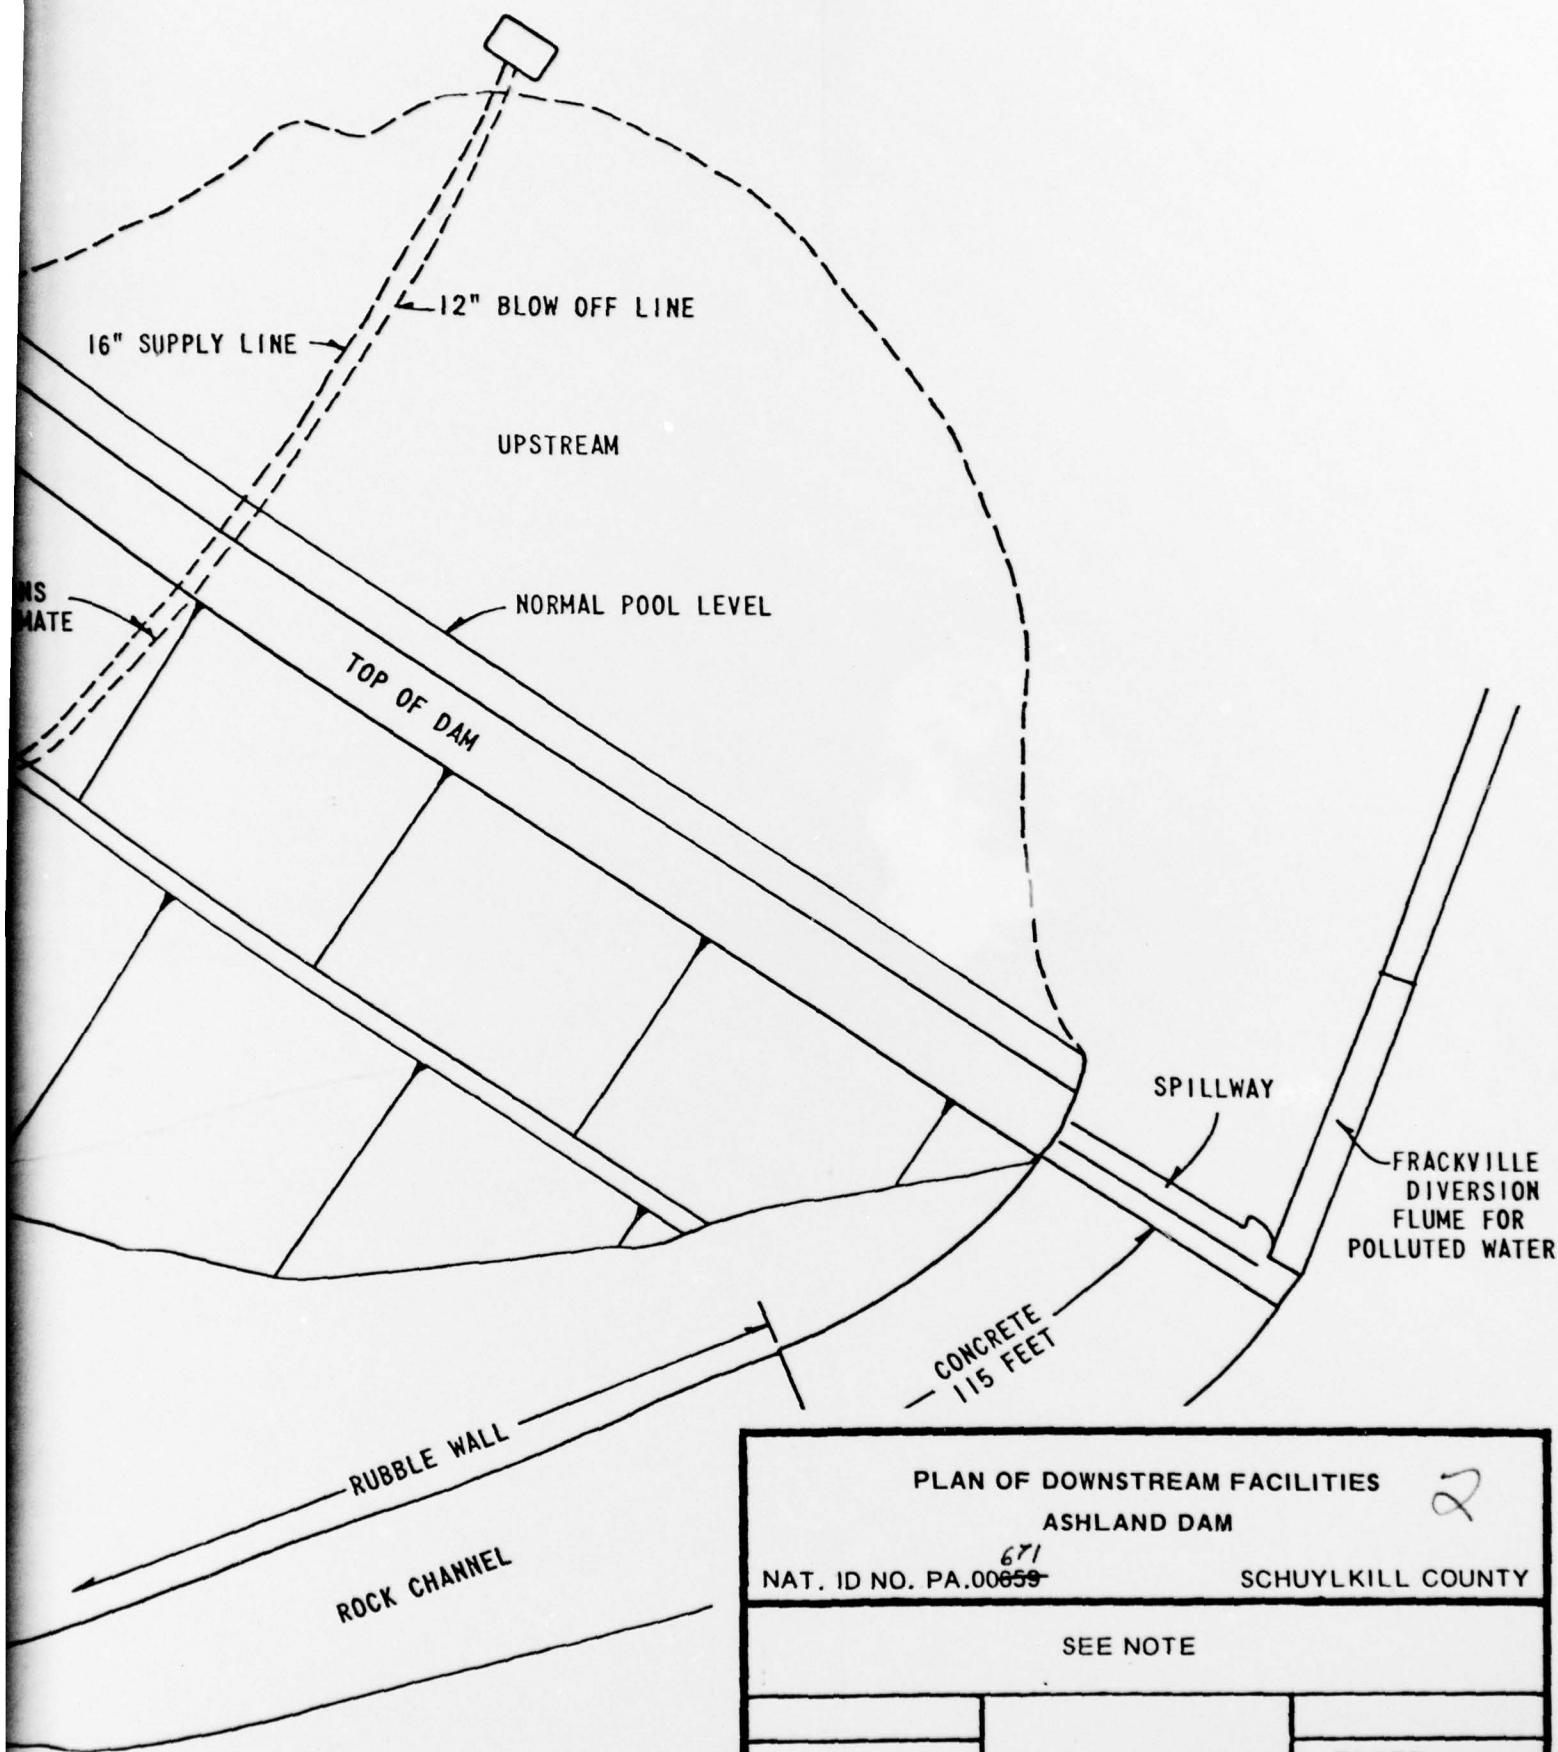
PLAN OF DOWNSTREAM FACILITIES ASHLAND DAM		
NAT. ID NO. PA.00659 <sup>671</sup>		SCHUYLKILL COUNTY
SEE NOTE		
		PLATE 4

Immediately upon filling of the reservoir leakage was noted on the embankment. This leakage was noted predominantly along the left side of the embankment and ranged from the toe to as much as 20 feet up the slope. This seepage was closely monitored for the next three years and in September 1929, as the amount seemed to be increasing, the State directed that weirs be installed to monitor this seepage. These weirs were installed by the Owner in June 1930, and weir measurements were taken from 1930 to 1940. Thereafter, there was no documentation in either the Department of Environmental Resources (DER) files or the Owner's files. In 1938, the Owner installed a french drain system at the base of the dam to alleviate the swampy condition at the toe. A blow-off pit was also installed just below the dam (see Plate 4, Appendix E).

In 1955, the Owner requested that the spillway be raised one foot to impound more water. This request was denied by the State because of the seepage emanating from the toe and the embankment area. Just prior to 1976 a downstream dike was installed immediately below the blow-off pit. (See Plate 4, Appendix E) This dike was constructed to control the spillway discharge.

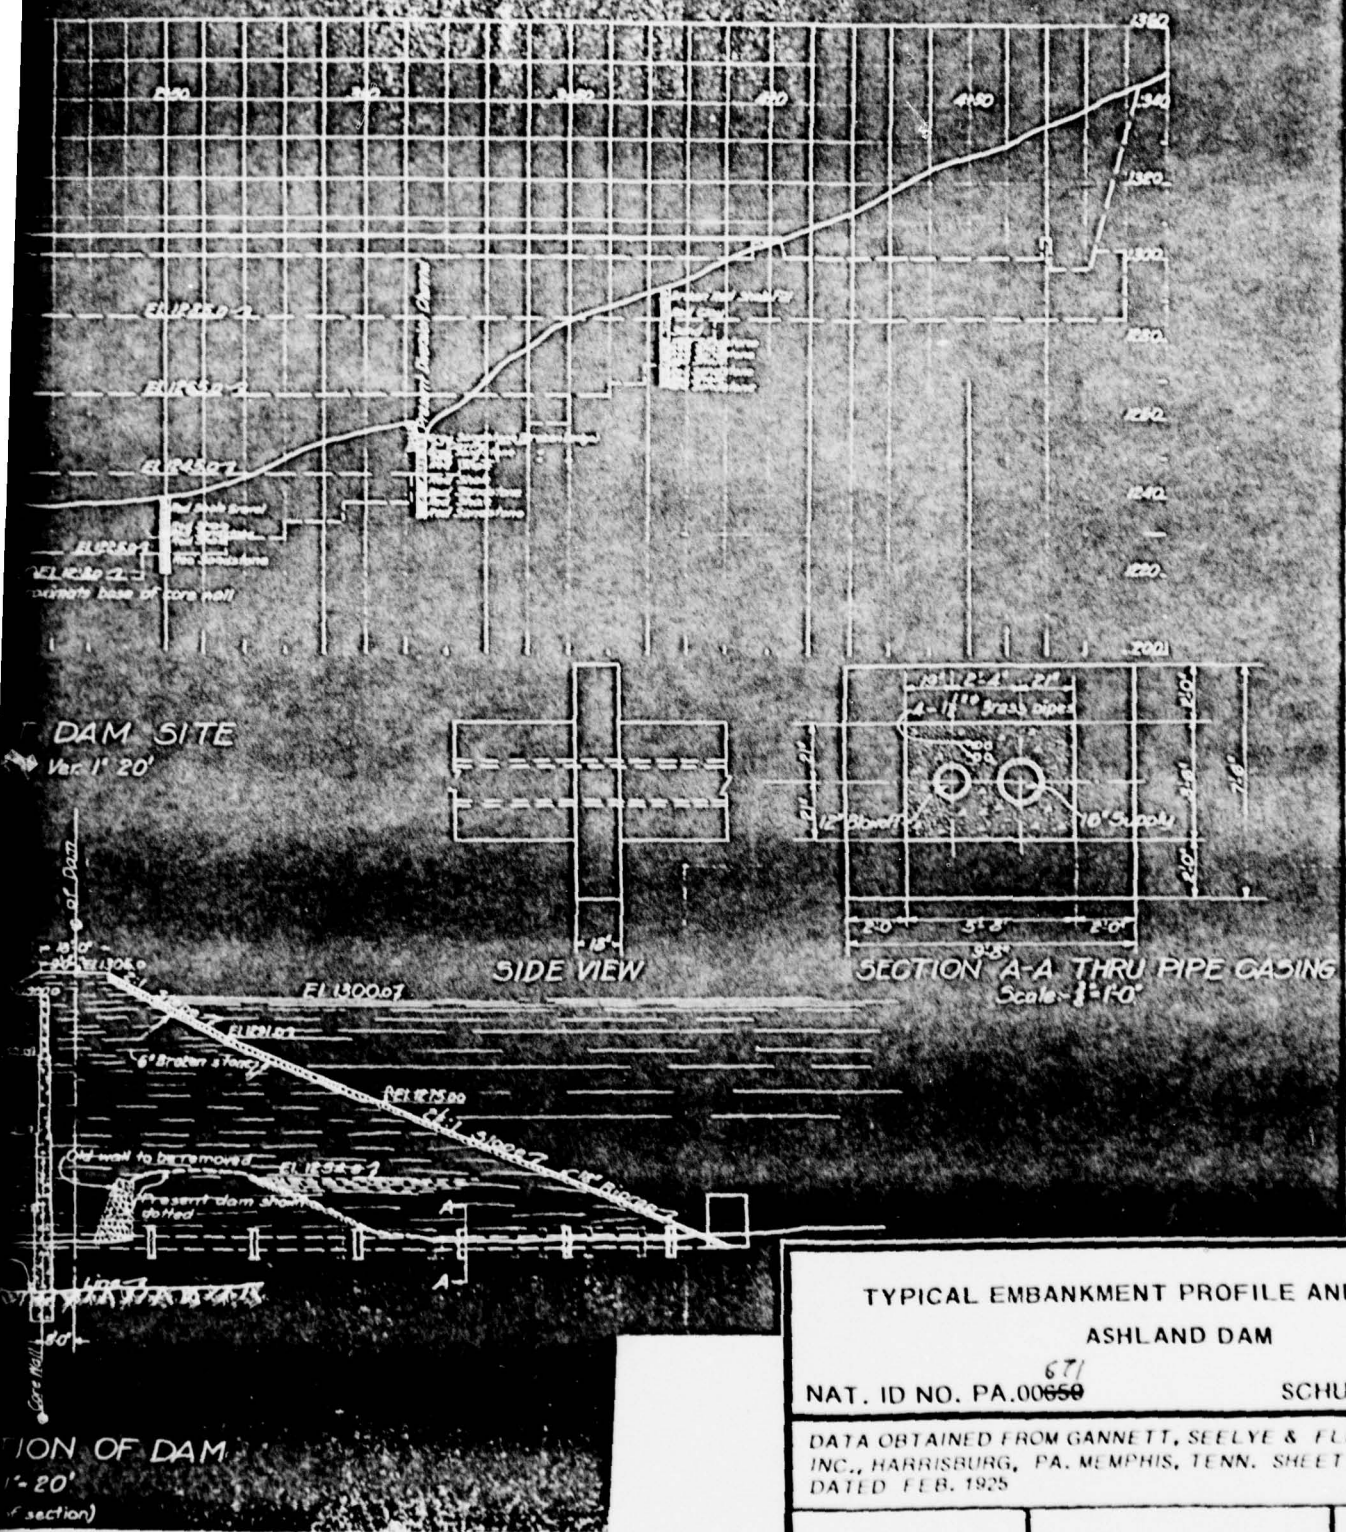
TYPICAL EMBANKMENT PROFILE AND SECTION			9
ASHLAND DAM			
NAT. ID NO. PA.00659		SCHUYLKILL COUNTY	
DATA OBTAINED FROM GANNETT, SEELYE & FLEMING, ENGINEERS, INC., HARRISBURG, PA. MEMPHIS, TENN. SHEET NO. 5 OF 12			
DATED FEB. 1925			
		PLATE 5

The downstream slope is 2H:1V with a 4 foot berm at elevation 1276 and a rock fill toe. A typical section is shown on Plate 5 of Appendix E.
